A Study on the Surroundings of Sednaoui El-Khazendar Historical Building in Khedival Cairo and Proposals for Improvement and Development

Ahmed Elyamani¹, Nourhan Mohamed Ali¹, Naglaa Abdel-Maksoud¹ and Aya Adel¹

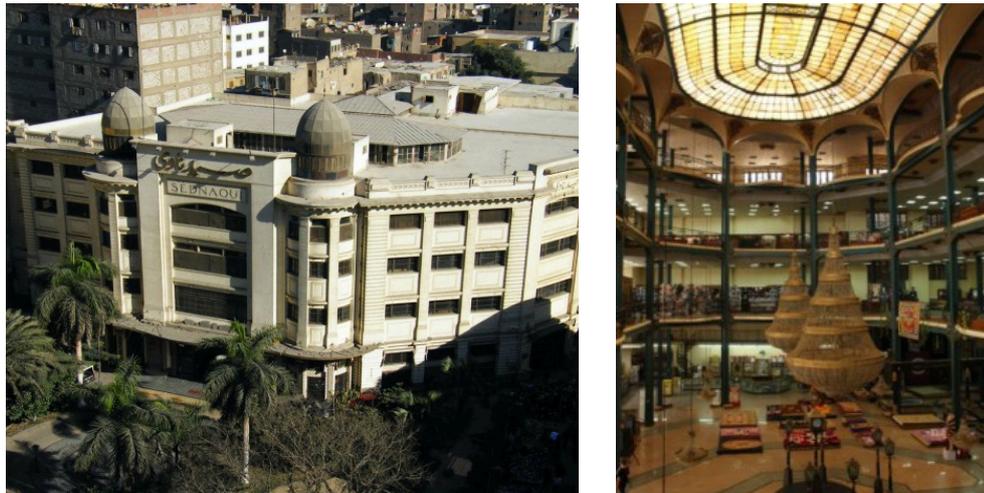
Figure 1. Sednaoui El-khazendar from outside showing main entrance (left) and from inside showing entrance hall, upper floors and central skylight (right).

Sednaoui consists of a basement, a ground floor and three typical floors (first to third). It is composed of steel beams rested on steel columns. The floors are made of reinforced concrete. The outer walls are made from stone masonry. Its spacious courtyard, located at the building's middle (Figure 1, left) is distinguished by its magnificent design making Sednaoui one of

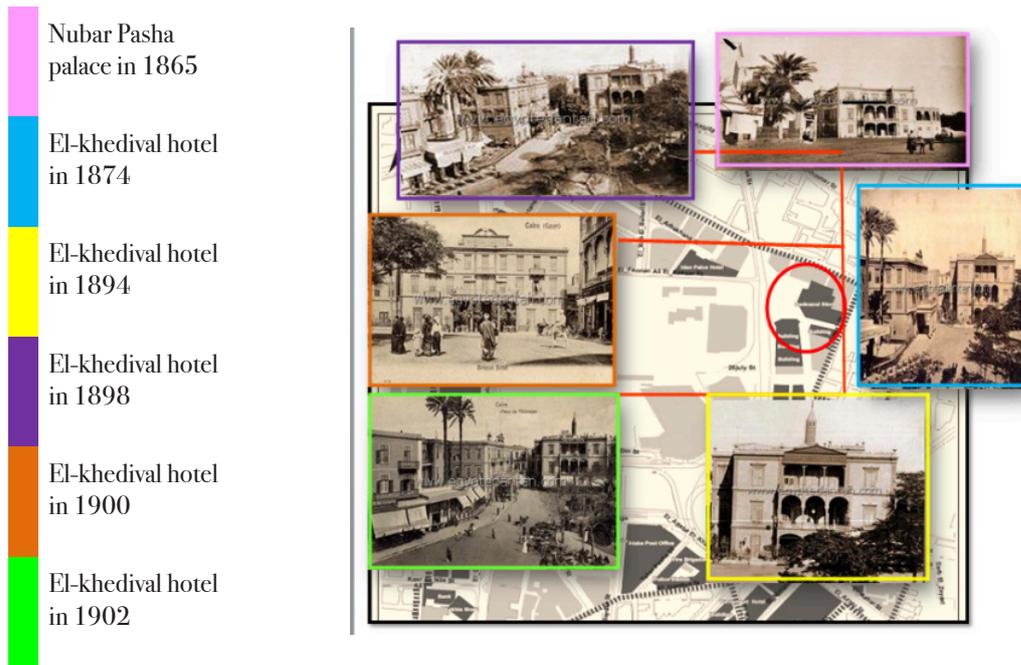
Figure 2. Construction development of the area of Sednaoui El-kazendar structure (surrounded by red circle) since 1865 to 1902.

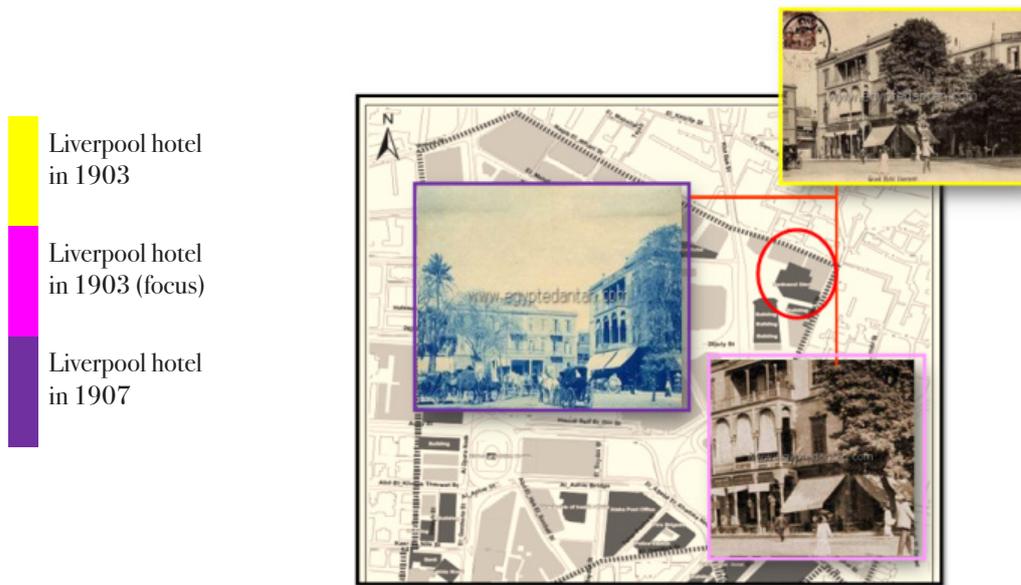
Figure 3. Development of Liverpool hotel (surrounded by red circle) since 1903 to 1907.

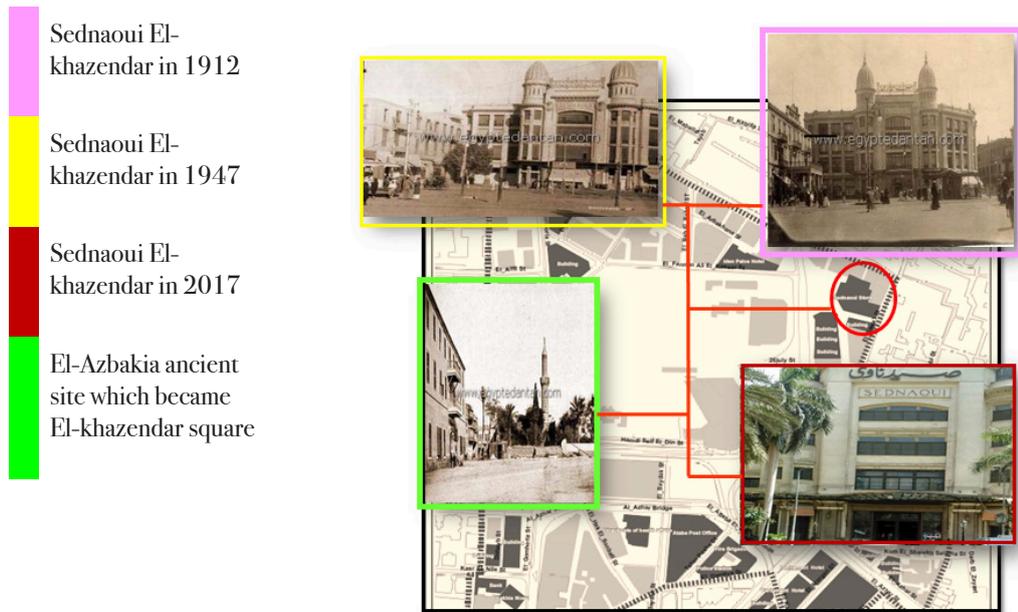
Figure 4. Development of El-khazendar square and Sednaoui El-khazendar (surrounded by red circle)

The area on which Sednaoui building was built has undergone many changes. The palace of Nubar Basha (Minister of Finance of Khedive Ismail) was built in this area, which was later turned into the Khedivial Hotel and evolved over the years to become Liverpool hotel which was demolished in 1911 and Sednaoui El-Khazendar was built instead of it, Figures 2-4⁹. The building which was considered an architectural and commercial landmark in the 1920s is located in the heart of the commercial city around Al-Azbekiya Park. The building's architecture belongs to the Baroque style which was employed in many other commercial buildings in Paris at that time.

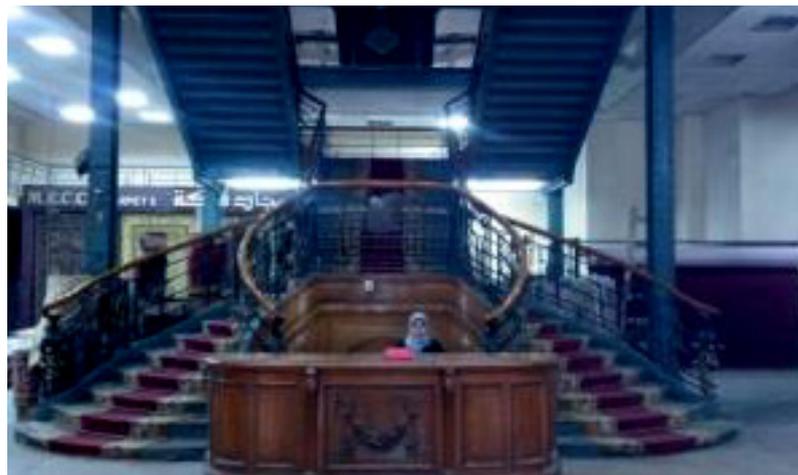
Figure5. Honorary stair in ground floor.

It has four facades; two of them are visible, the main (west) overlooks El-Khazendar Square and the other overlooks El-Qatawi Street. The two others are not visible because of the construction of new buildings around Sednaoui. The total height of the building is 28 m and its area is about 1900 m². The central part of the building is covered with a skylight that adds natural beauty to it when the sun passes through the colored glass (Figure 1, left). There is a small garden in front of the building which makes a buffer zone around it. The ground floor has an honorary stair that reaches the entire upper floors and is a highly emblematic architectural element, Figure 5.

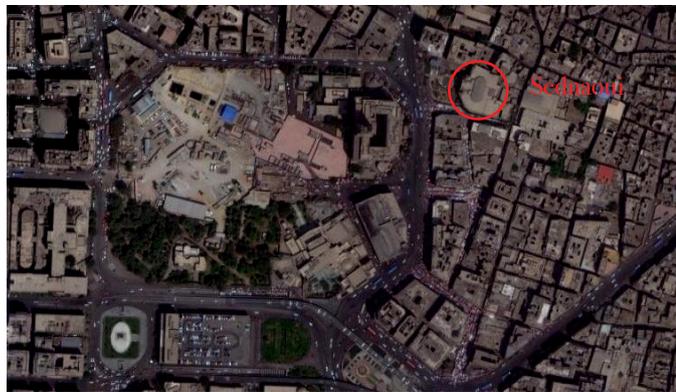
Figure 6. (a) Map of the borders of the zone under study, and (b) Aerial photo of the zone under study (adopted from Google maps).

The surroundings of Sednaoui building (Figure 6) includes the streets of El-Kassar, 26th July, El-Gomhorya, Hamdi Seif El-Din, and El-Ruwayi. As can be noticed, the building's location is distinct as it is the meeting point between El-Muski and Al-Azhar regions (on one hand) and Cairo downtown (on the other). The first two areas are characterized by their old and popular character, and their style is dominated by the old Islamic style; while the downtown is distinguished by its modern European-style buildings.

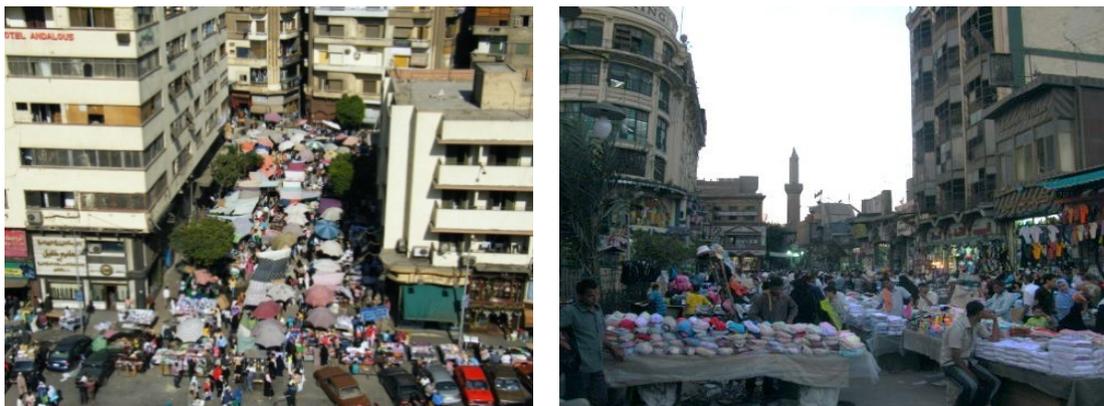
Figure 7. The extensive commercial activities and the spreading of street vendors and overcrowding in the surroundings of Sednaoui.

The area is currently suffering from the spread of street vendors, causing problems such as the difficulty of pedestrian and vehicular traffic, high levels of noise pollution, the disappearance of many facades of historic buildings in the area, the theft of electricity from light poles and the spread of garbage. The region also suffers from air pollution from exhausts gases. The lack of slopes that facilitate mobility for people with special needs are also noticed.

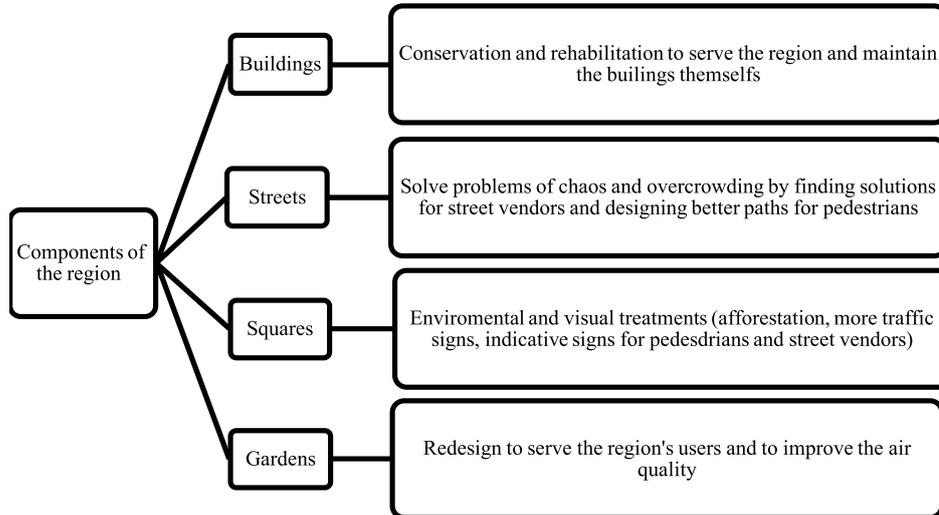
Figure10. Outlines of the proposals for improvement and development of Sednaoui’s surroundings.

The surroundings of Sednaoui have main strength and weakness points. The core objective of upgrading the surroundings of Sednaoui is to improve its condition by exploiting its strength points to the extent possible to overcome the weaknesses. Thus, this will be reflected in an improvement of the environmental and the social conditions of the region’s residents and visitors. In addition, the economic returns of region’s residents will increase. The outlines of the proposal for improvement are shown schematically in Figure 10. In the following paragraphs, a more detailed explanation of these outlines is given.

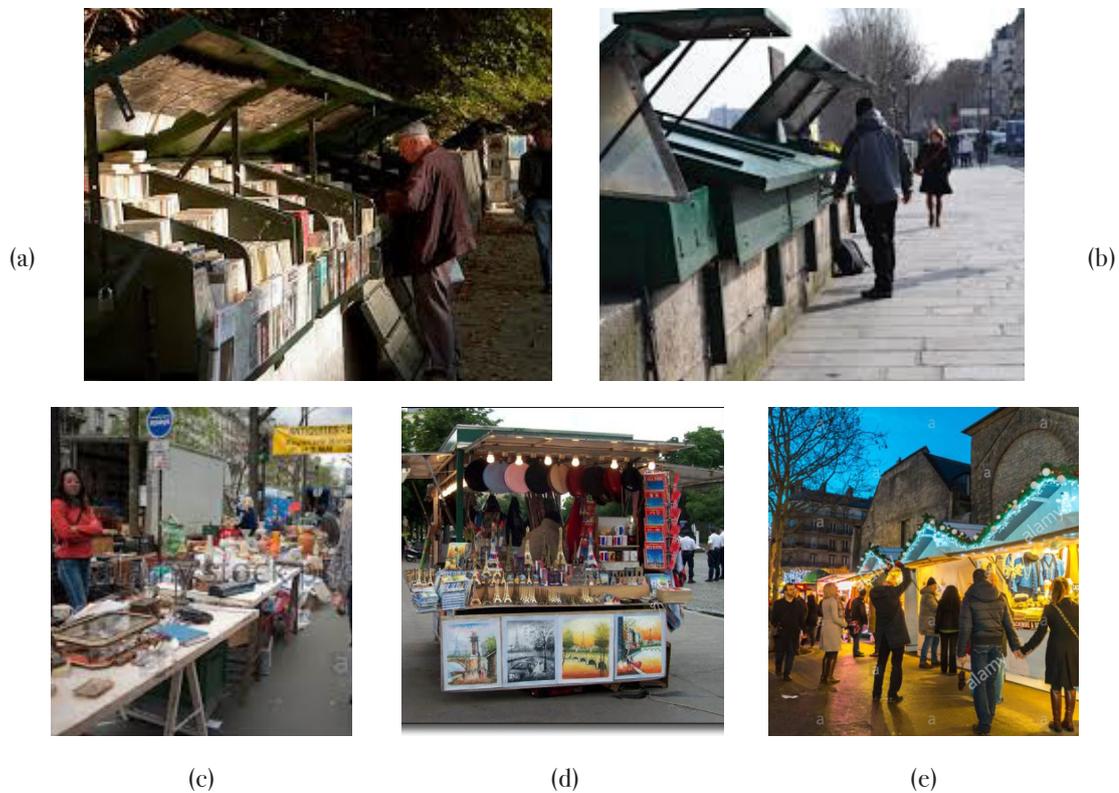
Figure 11. Several models of street vendors' goods in the Latin Quarter of Paris. (a) and (b) the way to sell and store books; (c), (d) and (e) the way to sell manual products.

To find a suitable solution to the presence of street vendors in the surroundings of Sednaoui and to avoid problems resulting from them, as mentioned before, we have been guided by what has been achieved in several countries that had the same problem. In Paris and in the Latin Quarter, one of the most crowded neighborhoods, the municipality has allocated several ways to display the products of the vendors (Figure 11). There are iron boxes to display, store books and protect them from sun and rain. These boxes are arranged on the side of the sidewalk so as not to hinder the movement of pedestrians. In addition, some of the side streets have been allocated for pedestrian traffic only and open tables with beautiful truss roof to display the goods in an organized way, spaced apart enough to allow movement while shopping¹³.

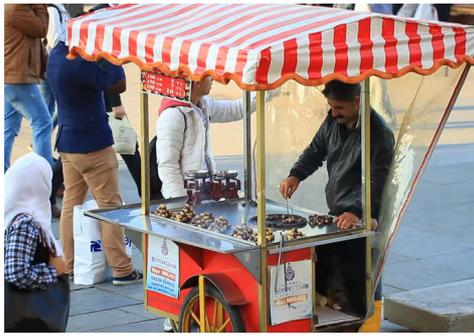
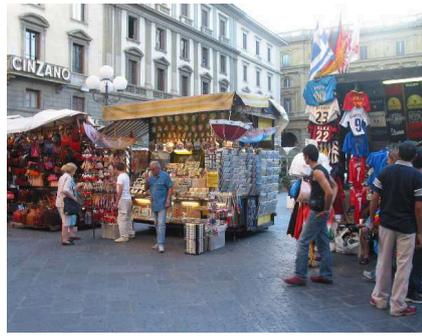
Figure 12. mobile carts (a) in Turkey and (b) in Italy.

In Italy¹⁴ and Turkey, we find that the idea of mobile carts for street vendors contributed to solving their problems, Figure 12. This proved to be a good idea to the street vendor who can move freely with his goods and increase selling opportunities. These carts are suitable for selling food and drinks. Unifying the shape, color, and size of these carts is essential in order for it to act as a landmark of the city and a tourist attraction. In Brussels¹⁵, the capital of Belgium, the Grand Place is dedicated on Saturdays to be the weekly market for various products such as flowers, clothes, household items and many other things. The idea of assigning one day per week for sale activities is a very good commercial idea. On one hand, the customers wait for this one-day market which increases the selling opportunities for street vendors. On the other hand, these markets are open on weekends only. Hence, closing one street for allocating the market does not affect much the traffic that is already less dense on weekends than on weekdays.

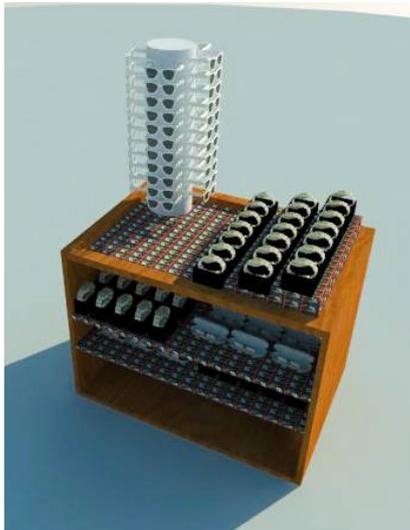
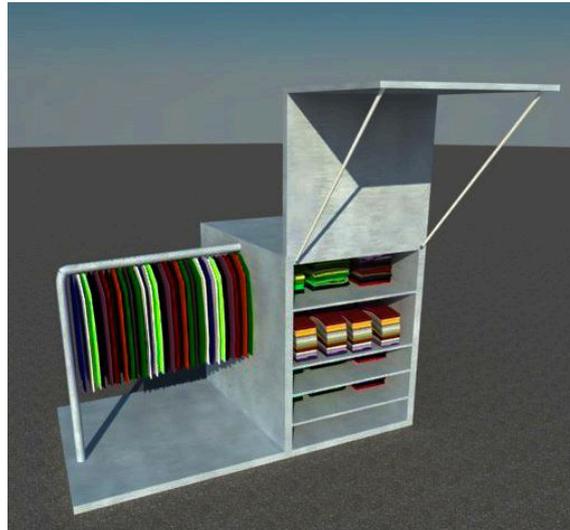
Fig.13. Two proposals to display and store of street vendors' goods(a) Sunglasses, watches and the like(b) Clothing and textiles

In this context, two proposals for presenting the goods of the street vendors are shown in Figure 13. One design is for presenting clothes and textiles and the other for goods like shoes, sunglasses, watches, and similar goods. The designs are suitable for both presenting and storing goods, since they do not require large spaces. Some buildings in the region can also be used after rehabilitation as commercial centers that can accommodate a large number of street vendors as will be mentioned in detail in the next section.

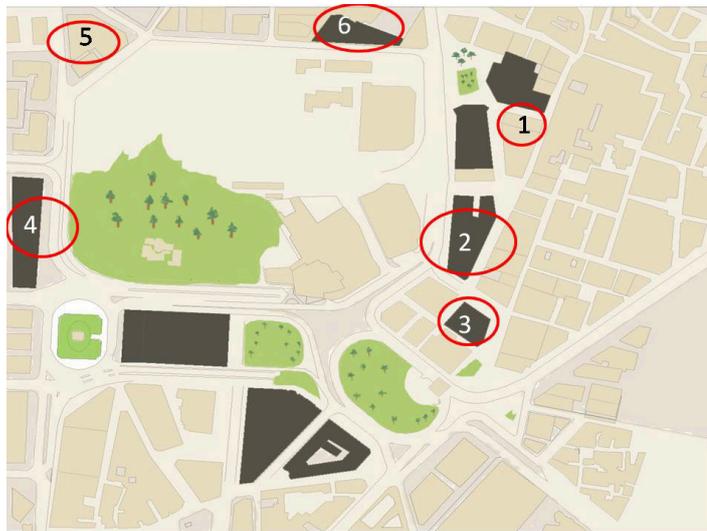
Fig. 14. Numbering of buildings in the region that can be rehabilitated and reused

rehabilitation, and reuse of archaeological buildings such as the Charters of Athens (1931)¹⁶ and Venice (1964)¹⁷, Nairobi (1976)¹⁸. Some of these buildings have large areas and can be reused as an educational and cultural center for the habitants of the region. Others are characterized by their several floors and large areas. The floors could be reorganized using light weight partitions into small shops and they could accommodate a large number of street vendors, Figure 14.

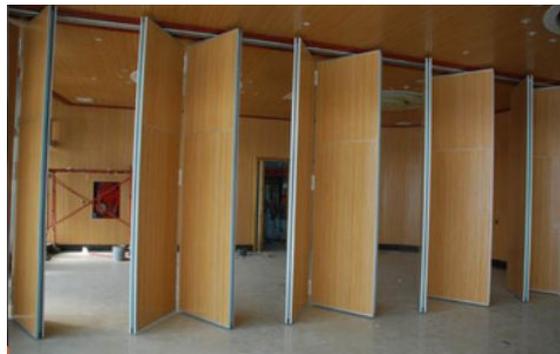
Fig. 15. Partition of the floor to small shops using light weight to help solve the problem of street vendors.

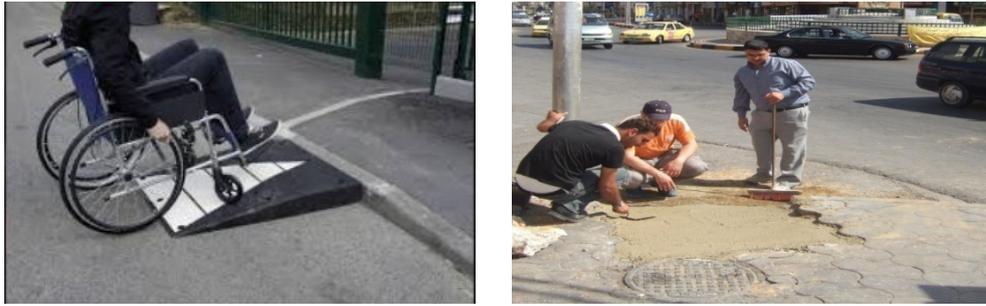
Figure 16. Add an earlier ramp to the pavement (on the left) and adjust the slope of the pavement after its collapse (on the right).
